Preliminary Building Code Review and Structural Assessment
of the
Greensboro Town Hall
Greensboro, Vermont

Barrett Architecture, PC with Schaal Engineering. PC
July 8, 2026

Part I
Preliminary Building Code Review
of the
Greensboro Town Hall
Greensboro, Vermont

Part II
Preliminary Structural Evaluation
of the
Greensboro Town Hall
Greensboro, Vermont

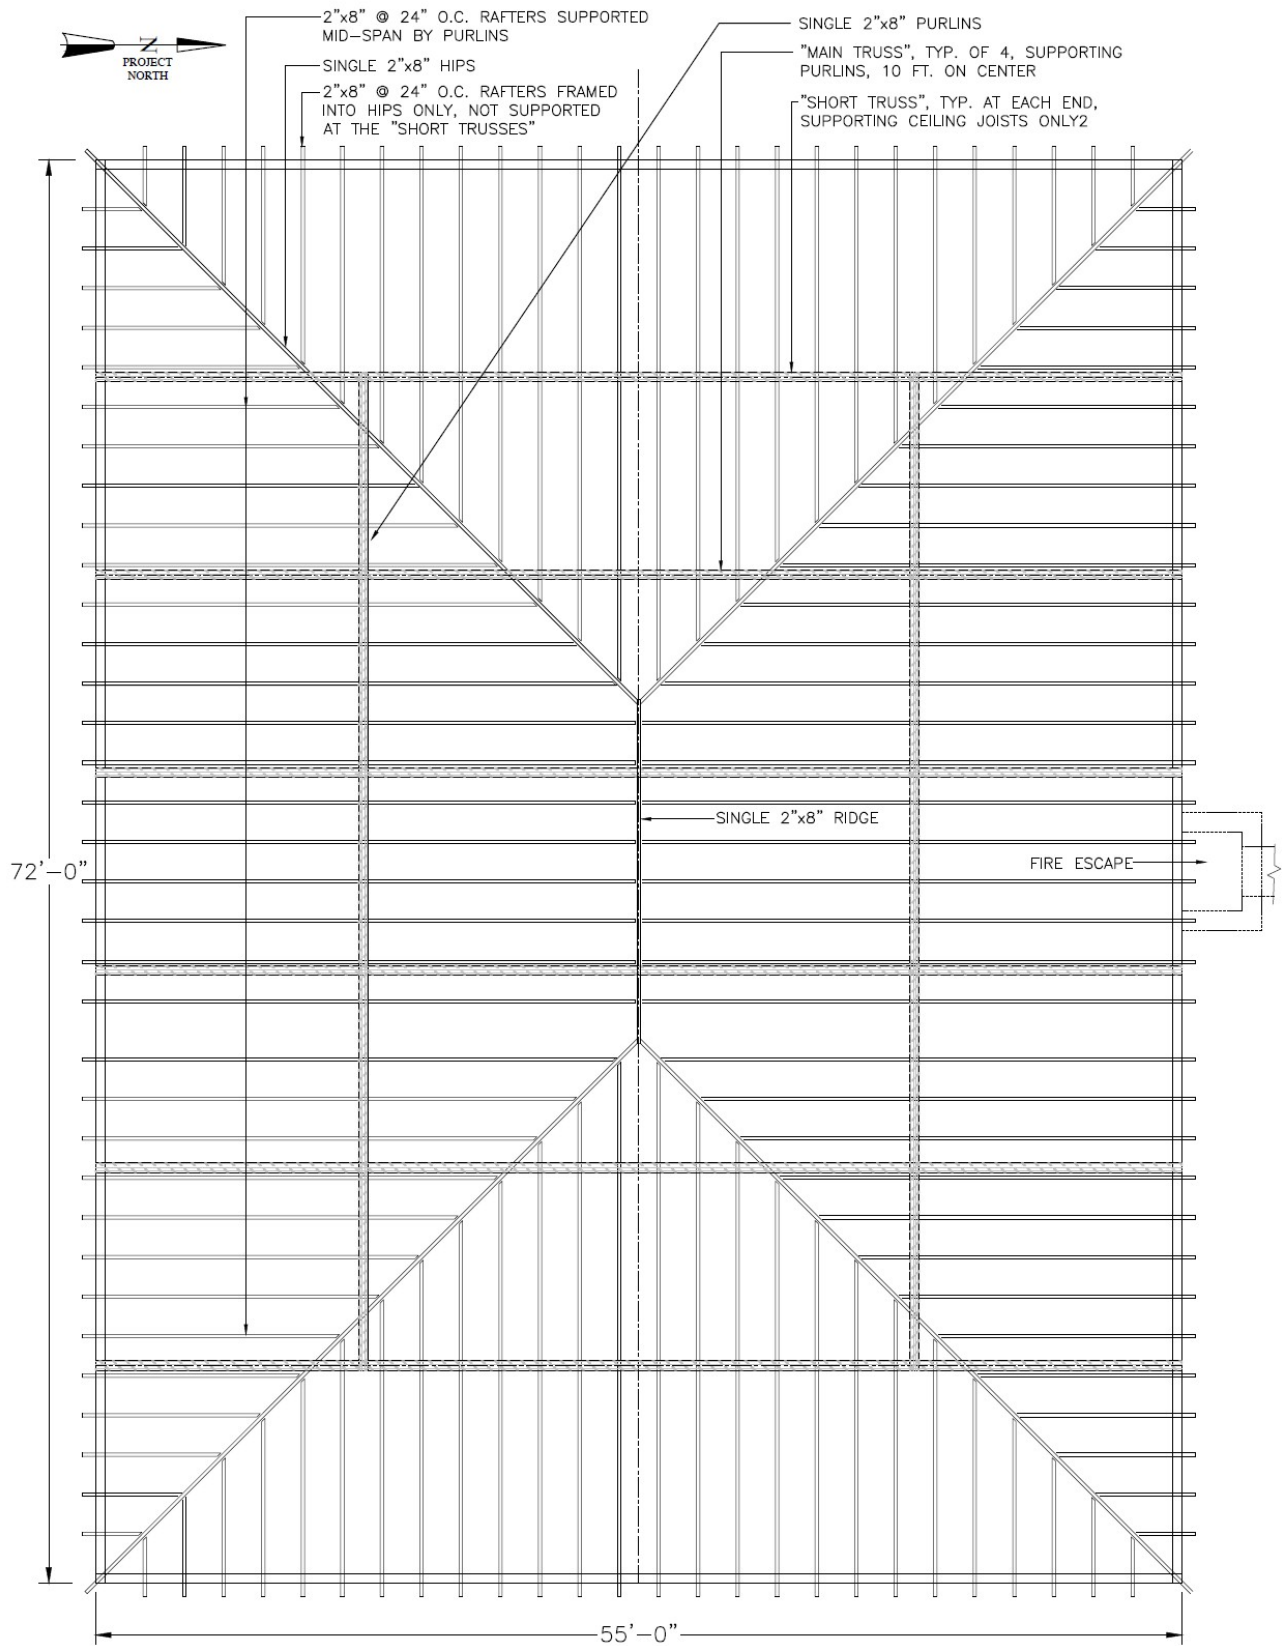
Schematic Roof Framing Plan (Not To Scale)

The roof structure however is of significant concern. Based upon past experience in evaluating and analyzing numerous historical buildings in Vermont and New Hampshire of similar size and type, the 6"x6" members used for the roof trusses are about half of the size of that observed in other similar roof structures. Given the calculated roof snow load capacities, it is unclear to how this roof has not had significant structural issues. It is likely due to the "factors of safety" inherent in the engineering analysis and calculations for allowable load capacities for timber framing, as well as snow melting and sliding from the roof snow before it becomes problematic.

With this said, the Schaal structural report calls attention to the very important matter of the overall roof structure. As preliminarily mapped out on the attached Schaal drawing titled *Schematic Roof Framing Plan*, dated June 30, 2026, and further described by Mr. Schaal within the pages of his report, the existing, original, roof framing is unlike anything that, simply stated, either of us have ever seen before. And again, simply stated, the roof structure is, and has long been, noticeably under-framed. Does this mean that the roof is on the verge of failure and collapse, probably not. But, if the building is going to be in continuous in the years to come, this issue must be addressed. More will be further said of this below.

A more comprehensive structural evaluation of the roof is recommended and should include thorough observation throughout the attic area to inspect the truss joinery, and the rafter and purlin conditions. This will require proper lighting, planked access throughout the attic area, and removal of insulation at the eaves and along the truss bottom chords. Once there has been a complete assessment of the conditions, an updated analyses and design of reinforcements can be completed.

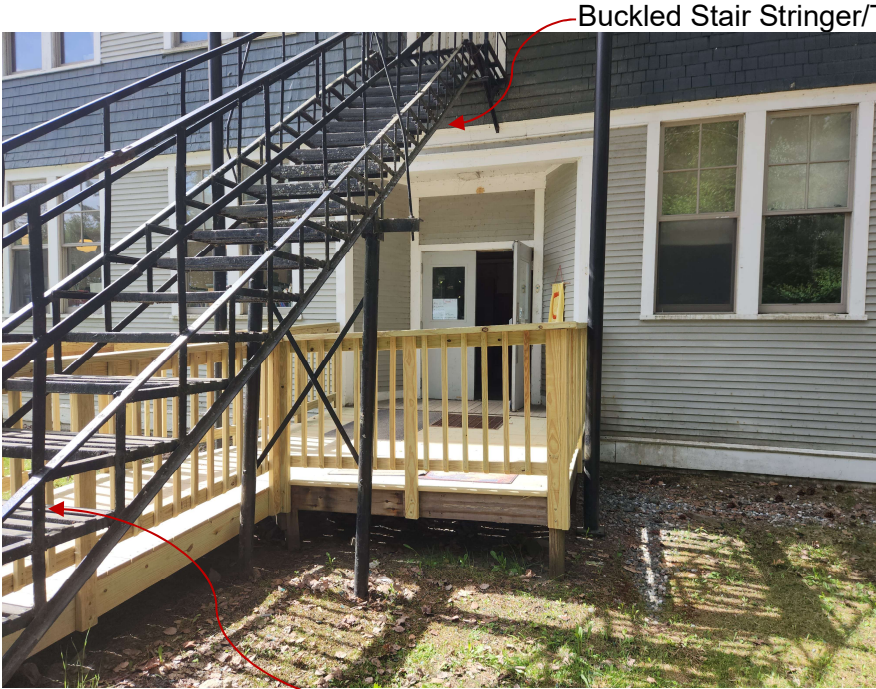
Fire Escape

The fire escape appears to be part of the original building and is constructed with riveted steel angles and flat plate "bar-stock," both of relatively small size; L1¼"x1¼" x 3/16" angles and 1¼"x 3/16" plate for the main structure and L1½"x1½" x 3/16" angles for the stair treads. The steel angles and bar-stock were fabricated in a manner to create a simple truss on each side of the stair which form both the stair "stringers" and railing assembly. These stair stringer "trusses" are supported on an at-grade concrete foundation, a mid-span post & beam assembly, and at a bracketed upper platform. See the photographs on Page 7.

- Splices of the stair stringer truss members at know "weak points."
- Obvious failures/buckling in the stair stringer truss
- When loaded in its weak axis (across the 3/16" dimension) the 1¼"x3/16" railing posts have an extremely low allowable load capacity of less than 25 pounds. The Code required loading is 200 pounds, applied in any direction at the top of the post.

Note: A detailed analysis of the stair stringer "truss" was outside of the scope of this preliminary structural evaluation. However, based upon observation and professional judgement, an analysis will likely show that the existing trusses are inadequate for the Code required 100 psf Live Load for Fire Escapes and Means of Egress.

Buckled Stair Stringer/Truss

1 1/4" x 3/16" Bar-Stock Railing Posts

6. Make necessary maintenance and repairs to the existing third floor steel fire escape to ensure its adequacy and safety in an emergency (see attached structural report).
