Greensboro Grange Building Greensboro, Vermont

Initial Building Assessment and Overview of Potential Uses

July 15, 2024

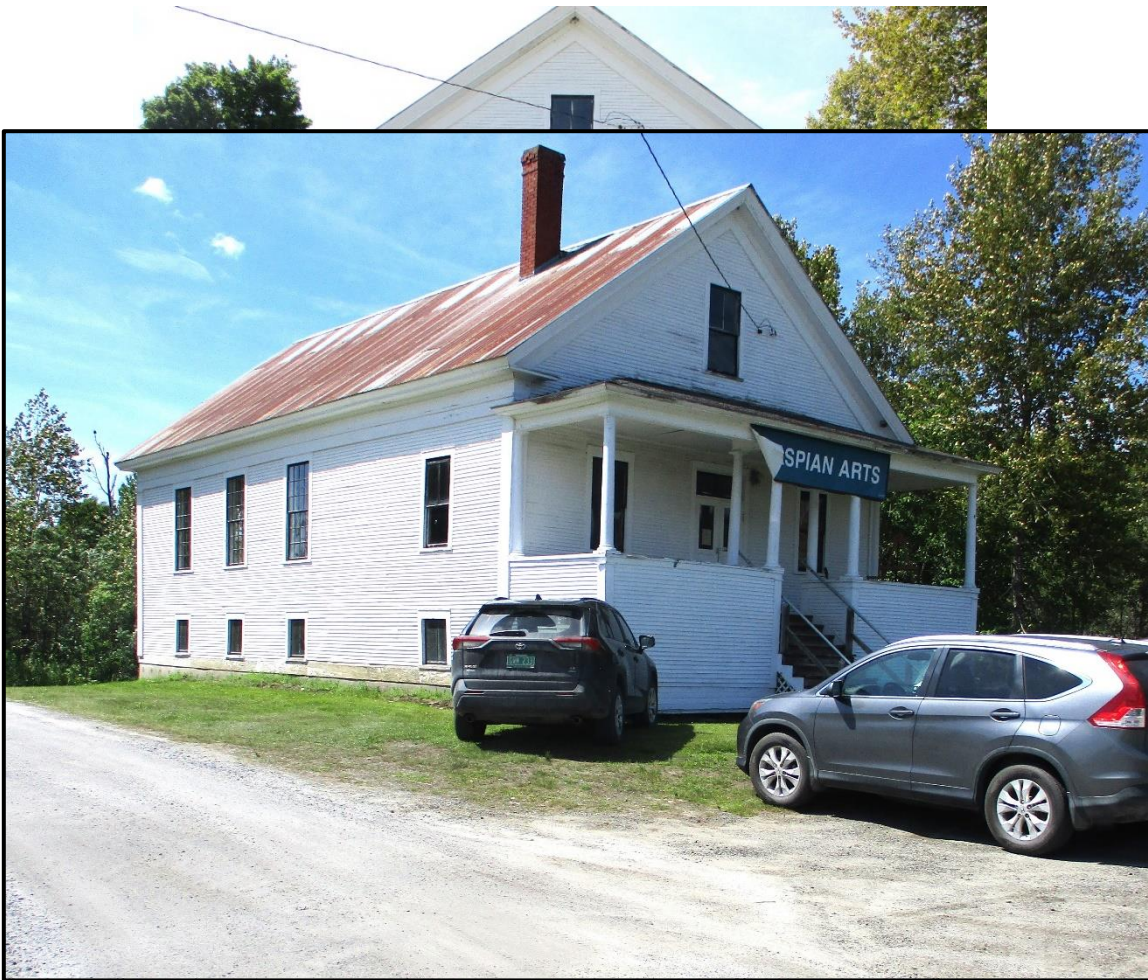
The easterly front of the building and the covered entry porch.

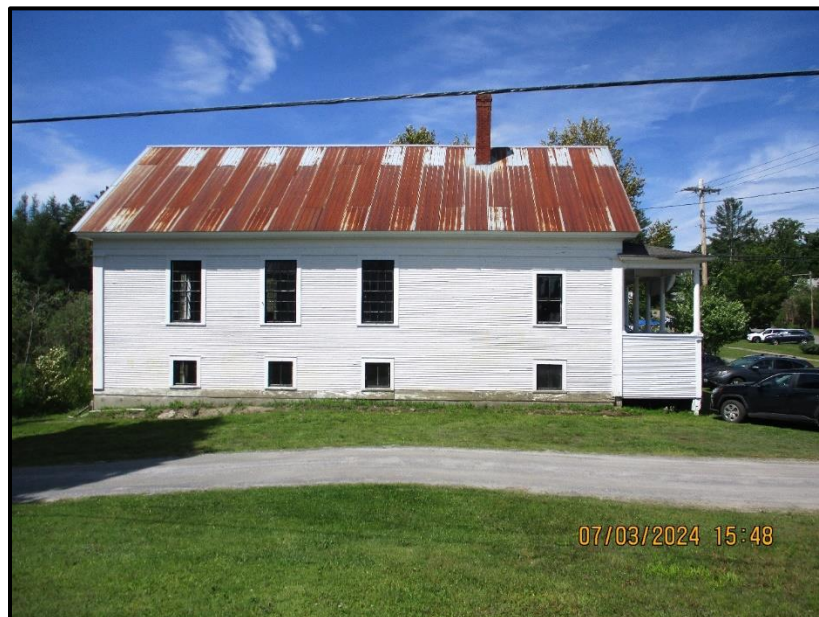
The southerly side of the building and Church Lane.
