Preliminary Building Code Review and Structural Assessment
of the
Greensboro Town Hall
Greensboro, Vermont

Barrett Architecture, PC with Schaal Engineering. PC
July 8, 2026

Part I
Preliminary Building Code Review
of the
Greensboro Town Hall
Greensboro, Vermont

Part II
Preliminary Structural Evaluation
of the
Greensboro Town Hall
Greensboro, Vermont

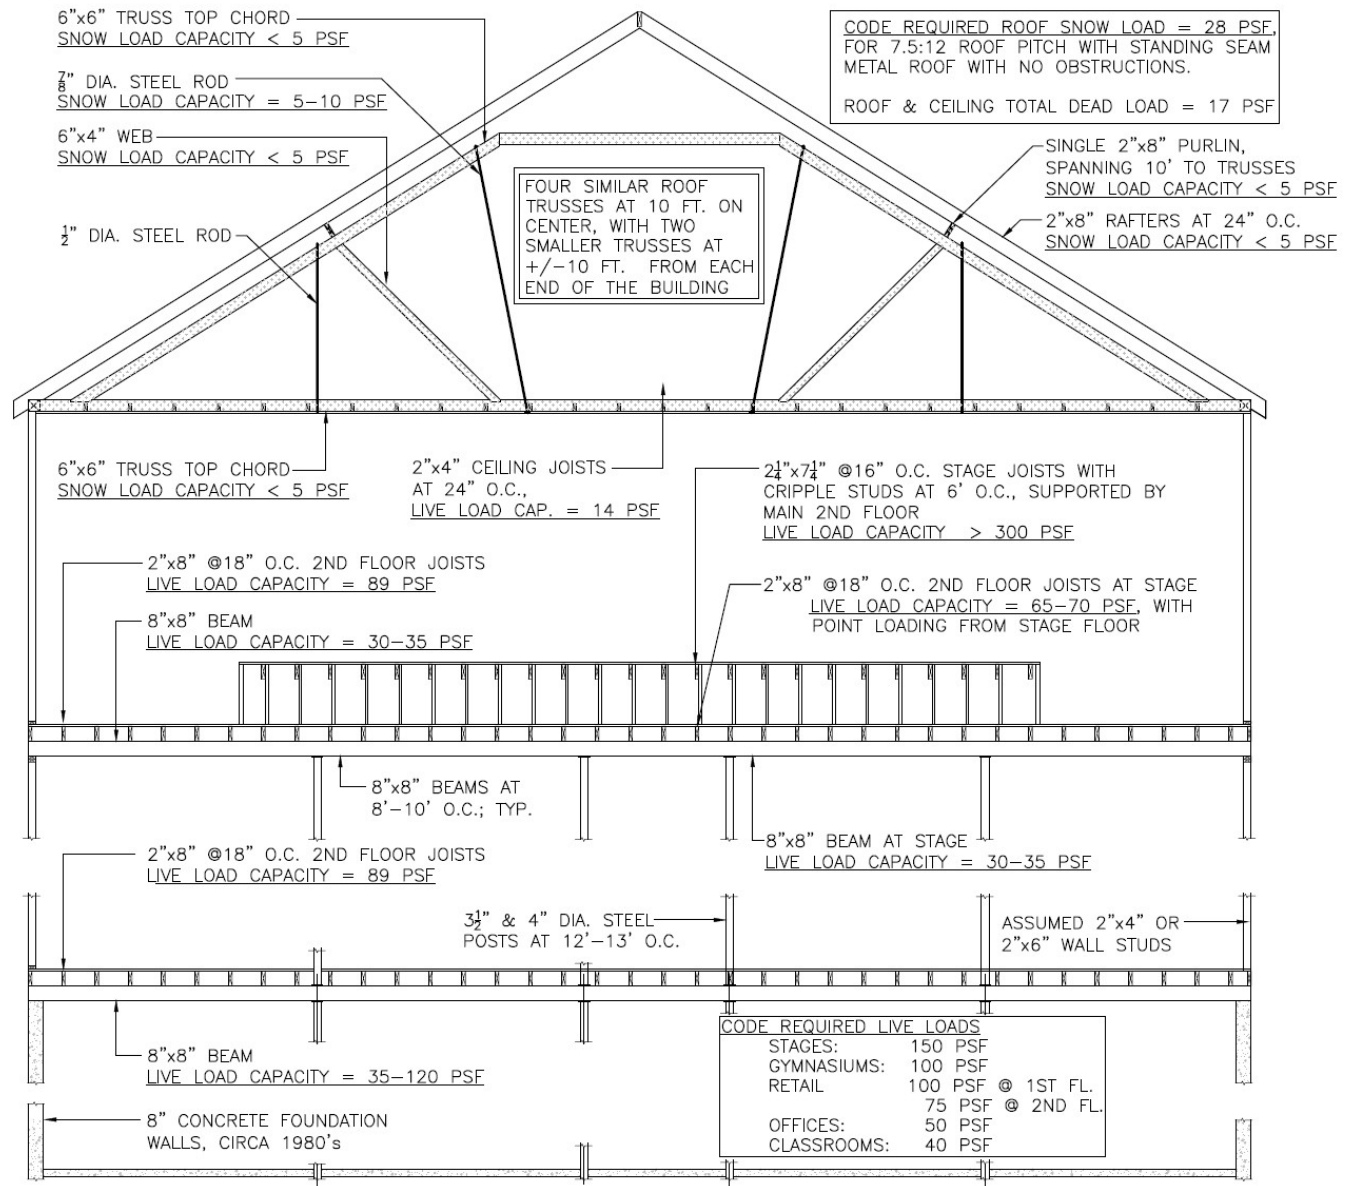
Schematic Roof Framing Plan (Not To Scale)

- 8" concrete basement foundation walls around the perimeter, presumably constructed during the circa 1983 renovations, and concrete slab-on-grade basement floor
- 3½" and 4" diameter steel posts at the second floor and basement.
- 8"x8" heavy-timber beams spanning 7-12 feet and bearing on top of the steel posts
- 2"x8" floor joists spanning 8-10 feet and bearing on top of the 8"x8" beams
- Heavy-timber & steel rod roof trusses spaced at approximately 10 feet on center and clear-spanning the 55' width of the building.
- Single 2"x8" purlins providing mid-span support to the main rafters
- 2"x8" rafters spaced at 24" on center, spanning from eaves to ridge and hip, with no splice at purlins
